Manhole Inspection Summary

Manhole # S49MM_007MH

Insp Date: **5/13/08 9:12 AM**

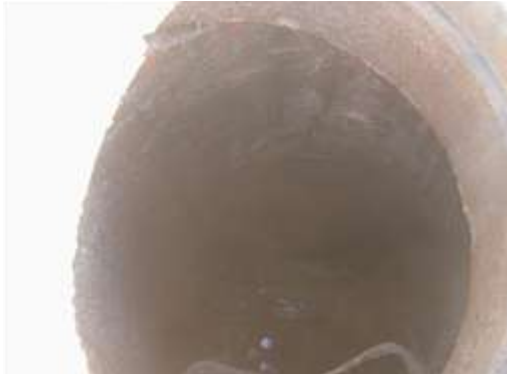
Defect 1

infiltration

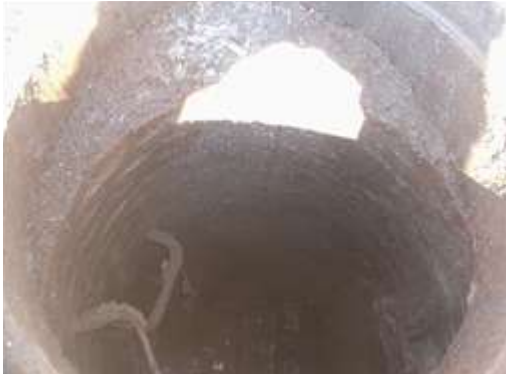
Defect 2

frame leaks

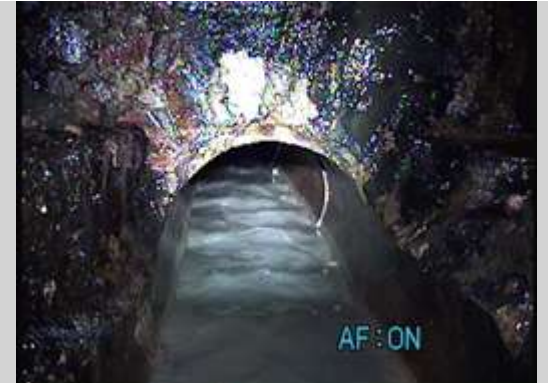
12 O'Clock Outflow

Pipe Height: **12** (in.) Rod and Bar (Angled)
Pipe Material: **Clay** ☐ Pipe Lined
Invert Depth: **15.50** (ft.) Flow Characteristics: **Fast**
Deposits: ☒ None ☐ Mud ☐ Sludge ☐ Debris ☐ Grease
Silt Depth: (in.) Deposits Extent:
Infiltration: **None** Pipe Seal Cond: **Sound**

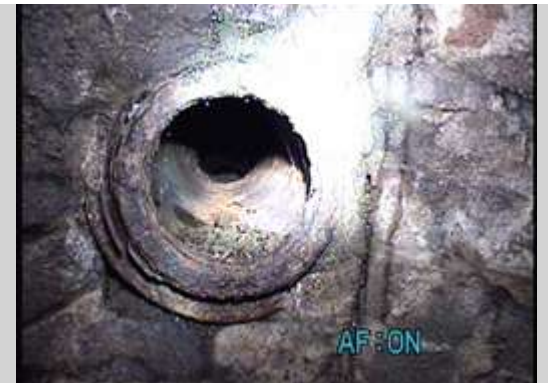
3 O'Clock Inflow

Pipe Height: **4.8** (in.) Rod and Bar (Angled)
Pipe Material: **Clay** ☐ Pipe Lined
Invert Depth: **4.00** (ft.) Flow Characteristics: **Slow**
Deposits: ☒ None ☐ Mud ☐ Sludge ☐ Debris ☐ Grease
Silt Depth: (in.) Deposits Extent:
Infiltration: **None** Pipe Seal Cond: **Sound**

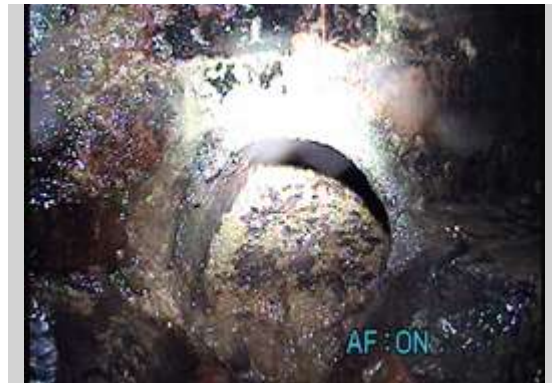
Drop In @ 3 O'Clock

Drop: **Outside** Rod and Bar
Angled: **Yes** Reading: **13.60** (ft.)
Inv Depth: **14.60** (ft.)
Drop Condition: **Clogged**

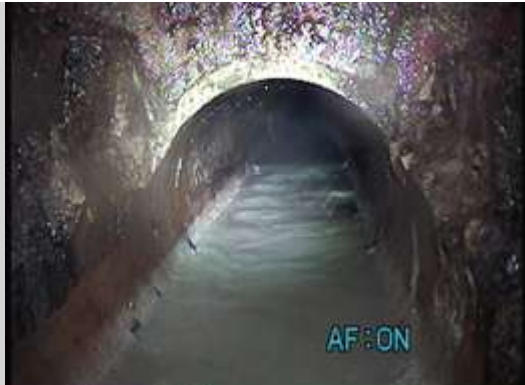
6 O'Clock Inflow

Infiltration: **None** Pipe Seal Cond: **Sound**
